MONUMENT RECORD  
State of Indiana - County of Monroe

Corner ID: Polk M-13

RECOVERY TIE DRAWING  
Field Book 39 Page No. 12

N13 F.S. Monument T7N R1E Sections 15,16,21 and 22  
 Polk\_M13

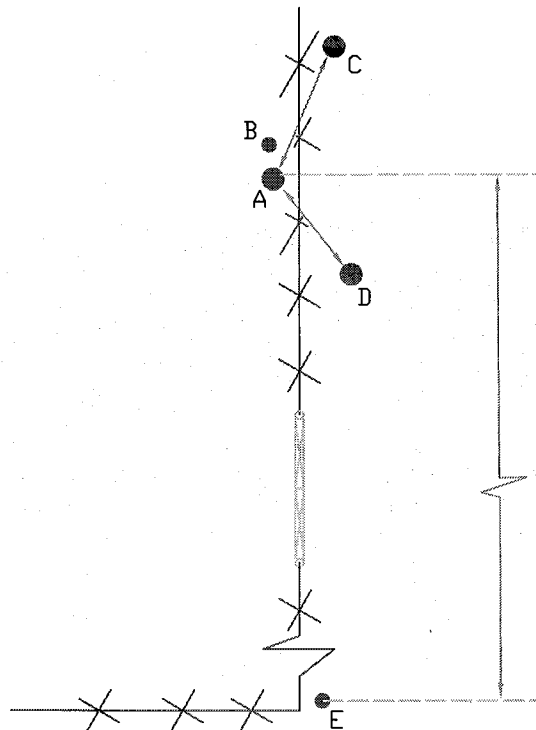
- A - 3" Brass Disk
- B - N 01° W 2.07' to Survey Sign on 4"x4"x4' wood post
- C - N 10° E 9.54' to Sign on 18" White Oak
- D - S 52° E 4.20' Sign on 72" Bifurcated Black Oak
- E - S 04° W 70.00' to 1/2" Iron Pipe with cap "GRAHAM"

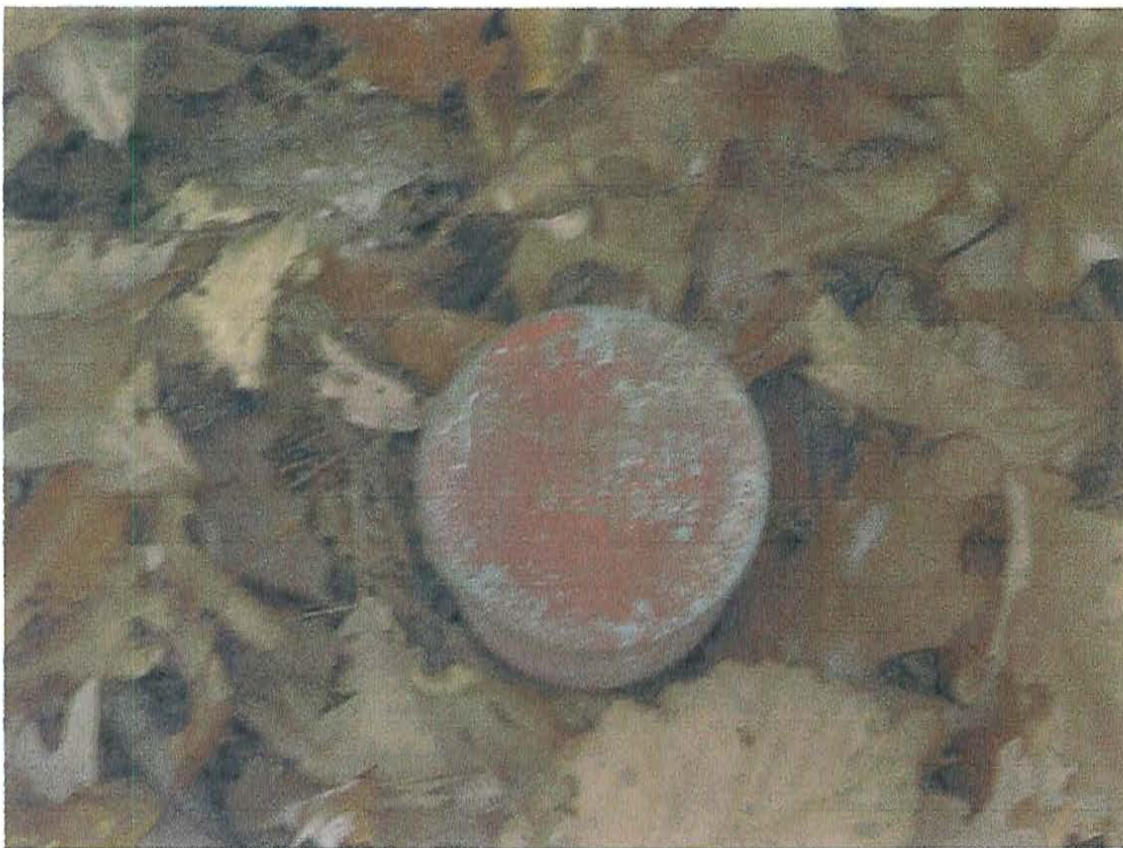
M13 T7N R1E

View to the Northwest
